## Improvement of Automotive Paint Blistering in Production Line

S.Z.A Sakinah<sup>1</sup>, W. H. Azmi<sup>1,2,\*</sup>, J. Alias<sup>1</sup> and N.N.M. Zawawi<sup>2</sup>

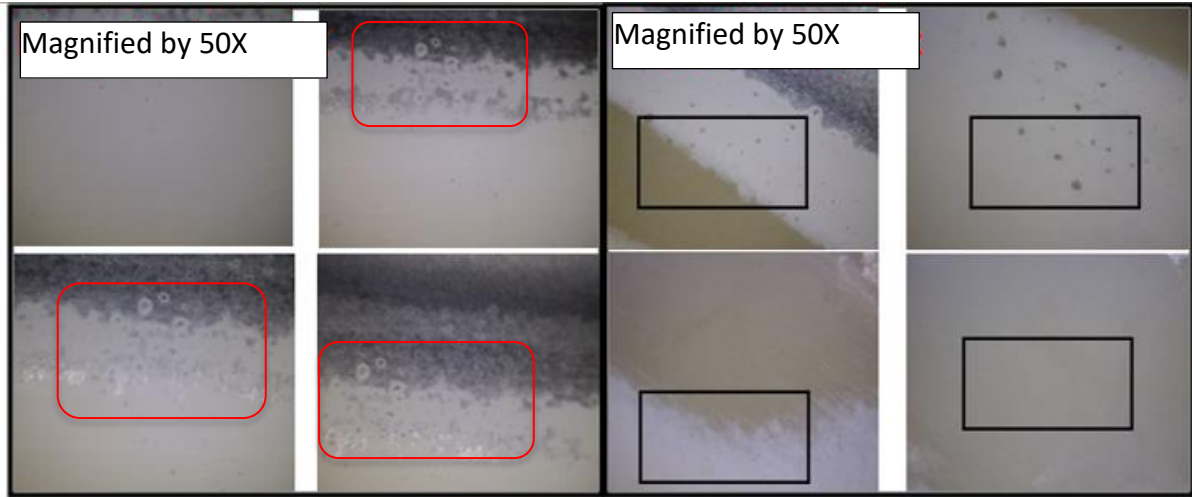
**Figure 1.** Blister Trend on Ed Surface

Special work team was formed and called as Quality Improvement team. Analysis of the blister was done by the help of this team. The number unit being analyzed was 18 cases. From these cases, 2 blisters were found between electrode deposition (ED) process and primer, the other 6 cases were found between primer and base coat colour. The first unit to be analyzed was a unit with blister at the right hand side of the front door. This unit was found with blister on November 2020. The blistering (from contamination) appeared on the paint surface with irregular blister pattern. During the observation using DYNOLITE, the blister looked like a pimple-like bumps or some kind of water in between the ED and primer surface. After layer sanding, it was confirmed that the blister appeared on the ED surface. The suspected root cause from this analysis was that the operator at the ED sanding conducted the sanding with contamination from outside; hence, leading to blister.

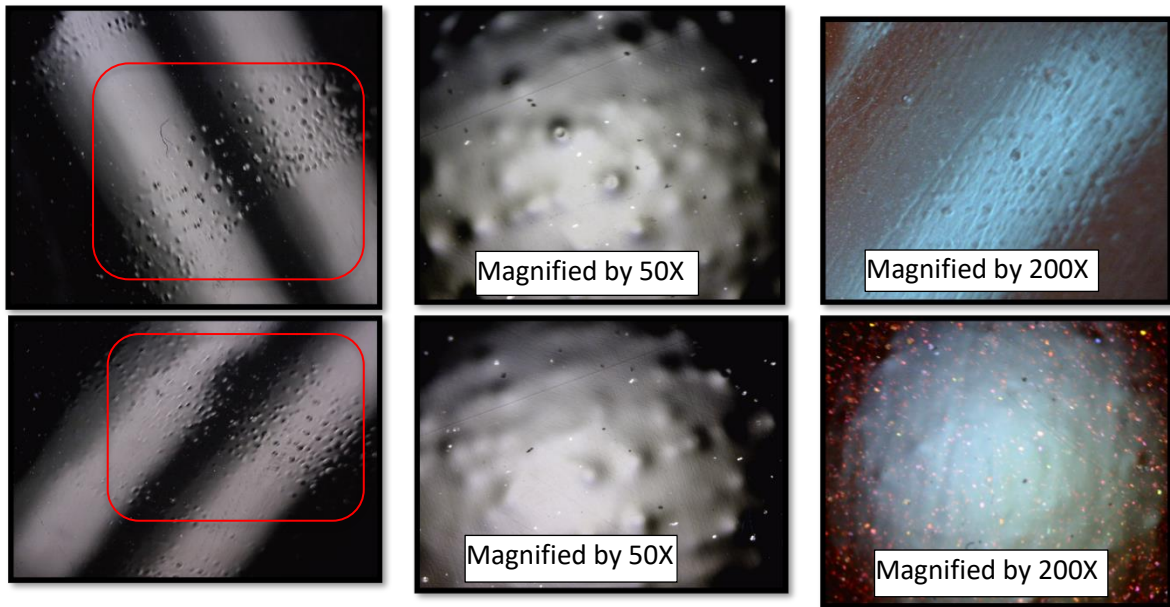
The second analyzed unit was the unit with blister which appeared on right hand side of C-pillar or in other words the fender. The blister appeared on dried paint surface and looked like a pimple and bumps or water mark. After layer sanding process by using the DYNOLITE, the blister was believed to be on the top coat layer as shown in Figure 2. This might be due to touching the unit with bare hands during the touch up paint process.

**Figure 2.** Blister trend on Top Coat Surface

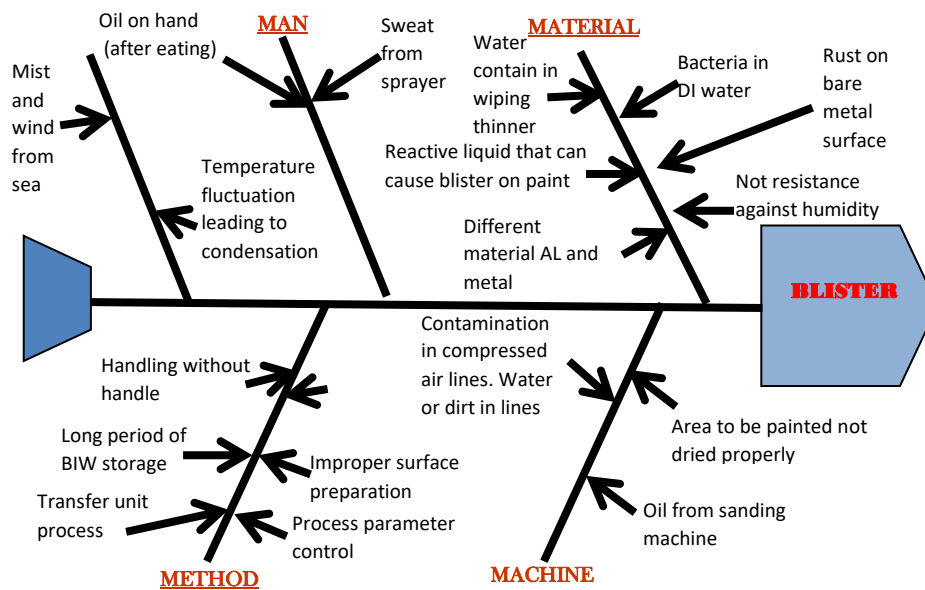
Root cause for the blister was list downed in terms of Ishikawa diagram or fish bone diagram as shown in Figure 3. All the possible root causes from Ishikawa diagram were done. This was then converted into the cause and effect analysis diagram in Table 2. These trials were run with the main objective to create blister from the brainstormed cause of blister. Only one of the trials managed to create blister which was the sweat from the operator hand while doing the moist sanding on the unit.

Figure 3. Ishikawa diagram for Blister contamination

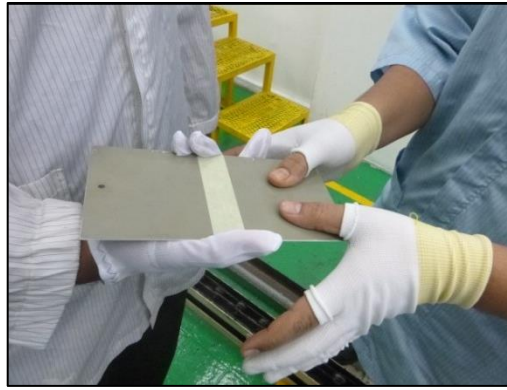
Figure 4 shows the trial method done to create and test the subjected root cause of blister in the production line. After two days, the panel started to produce blister on the paint surface. This trial used black colour paint. The second trial was conducted on the two units itself with the same method, but the only difference is that the unit was allowed to go through wiping process. The result for this second trial showed that the blister occurred on the first unit only after 1 day the unit was sprayed by the paint shop. The second unit for the second trial did not develop any blister. The target for this research was to tackle the blister on the current situation and for the year 2020.

**Figure 4.** Trial for blister method

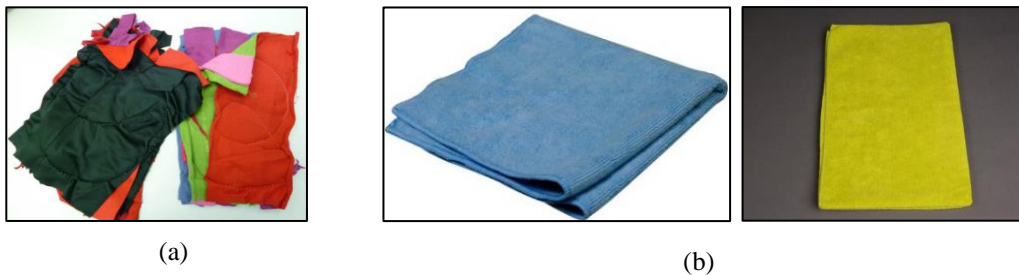
**Figure 5.** Replacement of Wiping clothes from sew rag (a) to microfibre (b)

The first improvement done was the replacement of sew rag that was normally worn for better adhesion and water absorbend such as the microfibre as shown in Figure 5. The microfibre was used for automotive surface body and approved by the production quality team. After replacing the wiping item material, there was a decrease in the paint defect and not just for blister.

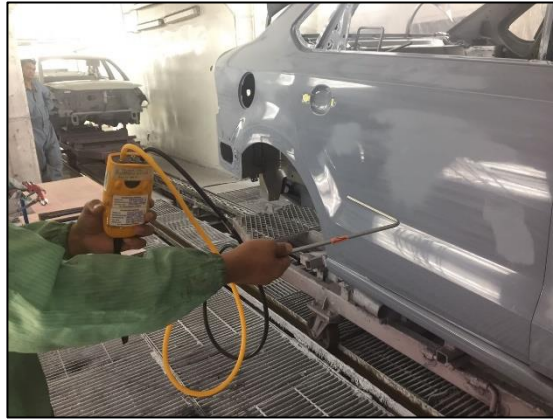
**Figure 6.** Air flow checking

To tackle the human sweat from the operator and the oil from the body and human hand, the spray booth was secured with updated air ventilation process since this air ventilation helps the human to work in a normal condition and balance the humidifier situation. Figure 6 shows that the downdraft of air ventilation is checked every day before spraying process starts. The operator was enforced to wear glove at all times including when handling the car body or even pushing it on the trolley. The fewer operators who touch the vehicle, the less risk for the vehicle to have defect like blistering. Since the problem can be tackled during the preparation process, the paint shop can be in a better quality condition and it helps to improve the quality of vehicle painted at the paint shop.

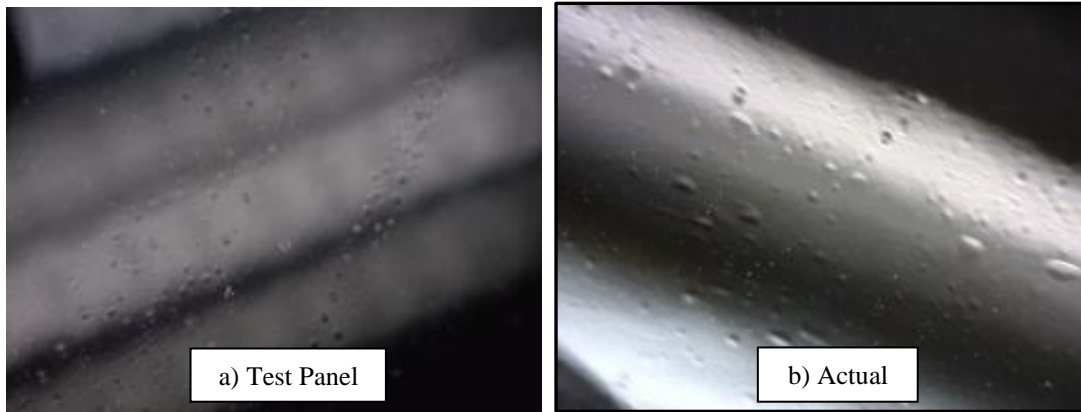
One of the main causes of this phenomenon was osmotic pressure developed by the meeting under and in between the different layers of the coating of water-soluble salts of all sorts. In fact, the blisters which occurred in sizes varying from pin-points 10 to 35 mm in diameter were found to contain acid and salty water mixture as

shown in Figure 9. They were situated between the primer and tile metal or between the primer and the top coat. Thus, any paint film will blister if weather conditions are bad enough, regardless of when the vehicle is painted. Cars painted in the summer months will often not show blistering until the monsoon and some may have been painted even years ago and can have blister during the months [24]. Figure 10 shows the improvement of blister after some actions were taken to tackle the blistering problem at the paint shop production line. This confirmed that the action taken was the most important in order to eliminate the blister effect during production process.

Figure 9. Result for Blister
