## Improvement of Automotive Paint Blistering in Production Line

S.Z.A Sakinah<sup>1</sup>, W. H. Azmi<sup>1,2,\*</sup>, J. Alias<sup>1</sup> and N.N.M. Zawawi<sup>2</sup>

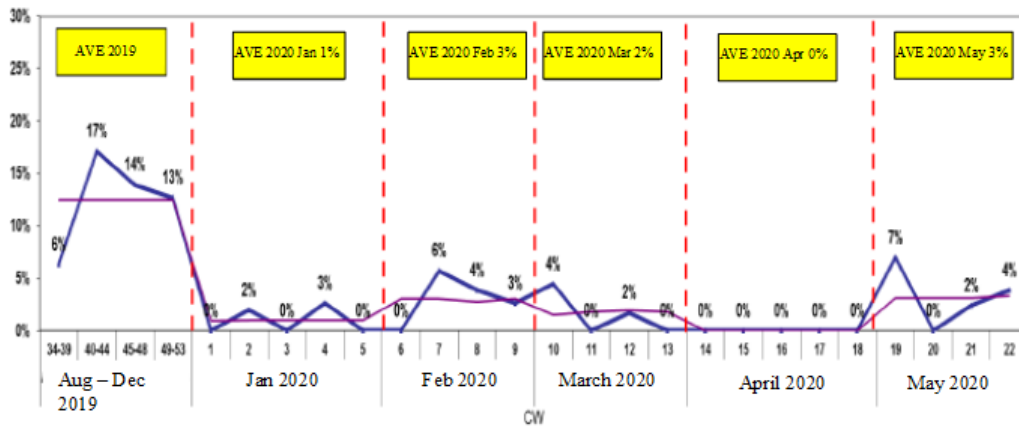
**Figure 7.** Graph of blister at the first quality Inspection (FQG 1)

Based on the results of implementation to reduce the number of blistering in the automotive paint production, we can see that the effect of the improvements made was enough to provide significant results on the decrease in defect as shown in Figures 7 and 8.
